Fort Riley,
Building # 107
107 Reed Avenue
Fort Riley
Riley County
Kansas

HABS No. KS-54-L

HISTORIC AMERICAN BUILDINGS SURVEY

FORT RILEY, BUILDING # 107

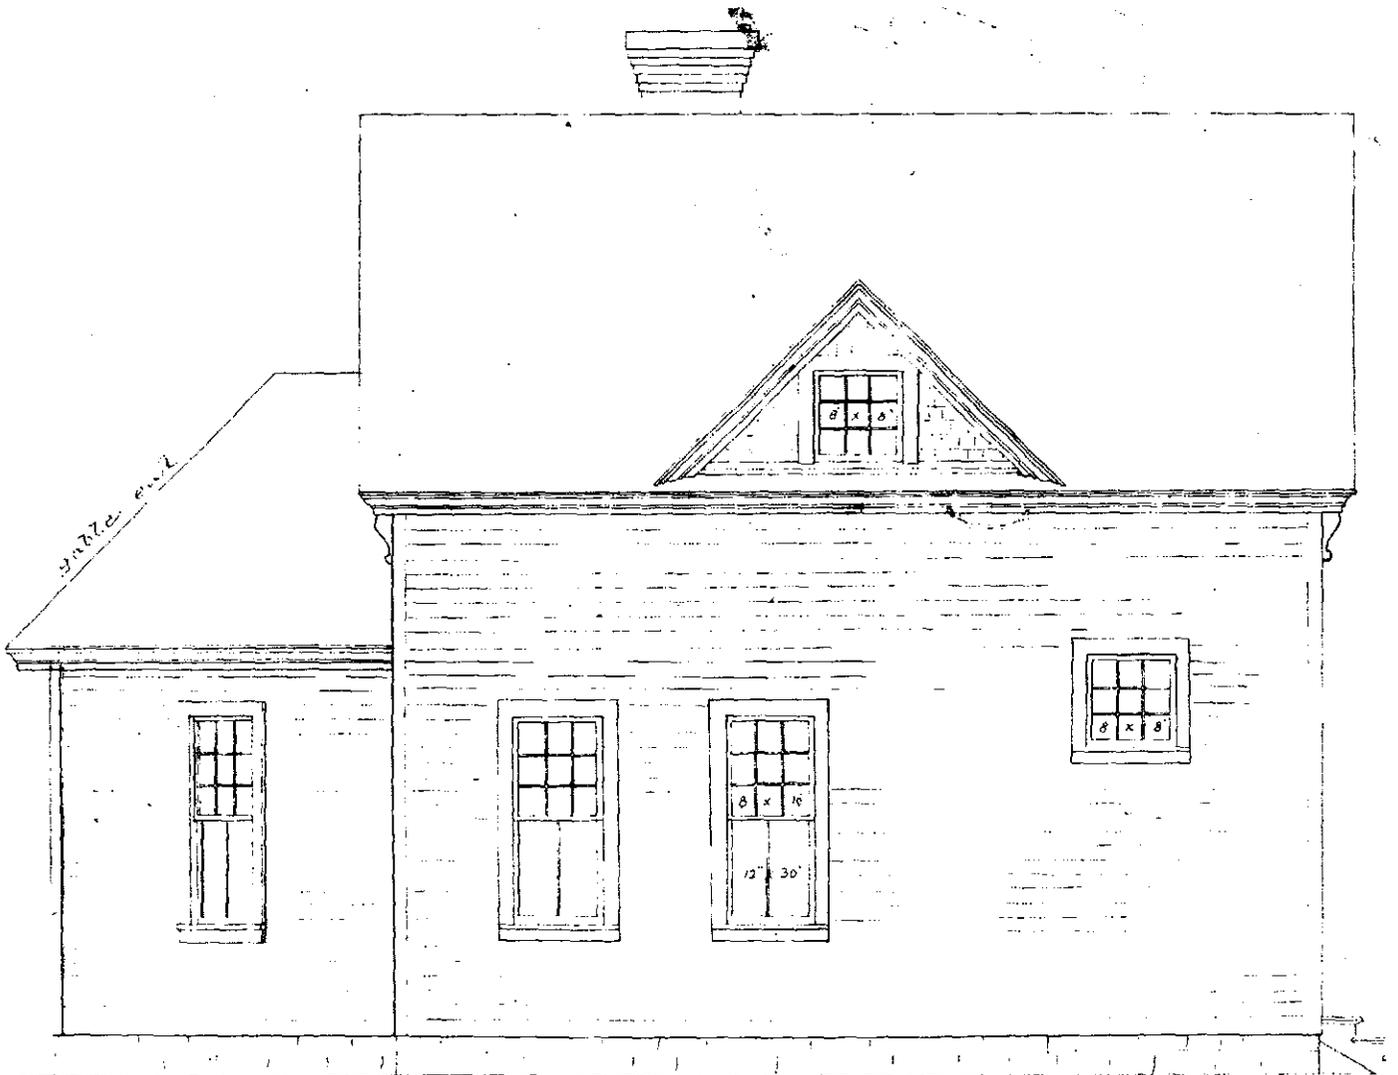
2. Side Elevation

Side Elevation

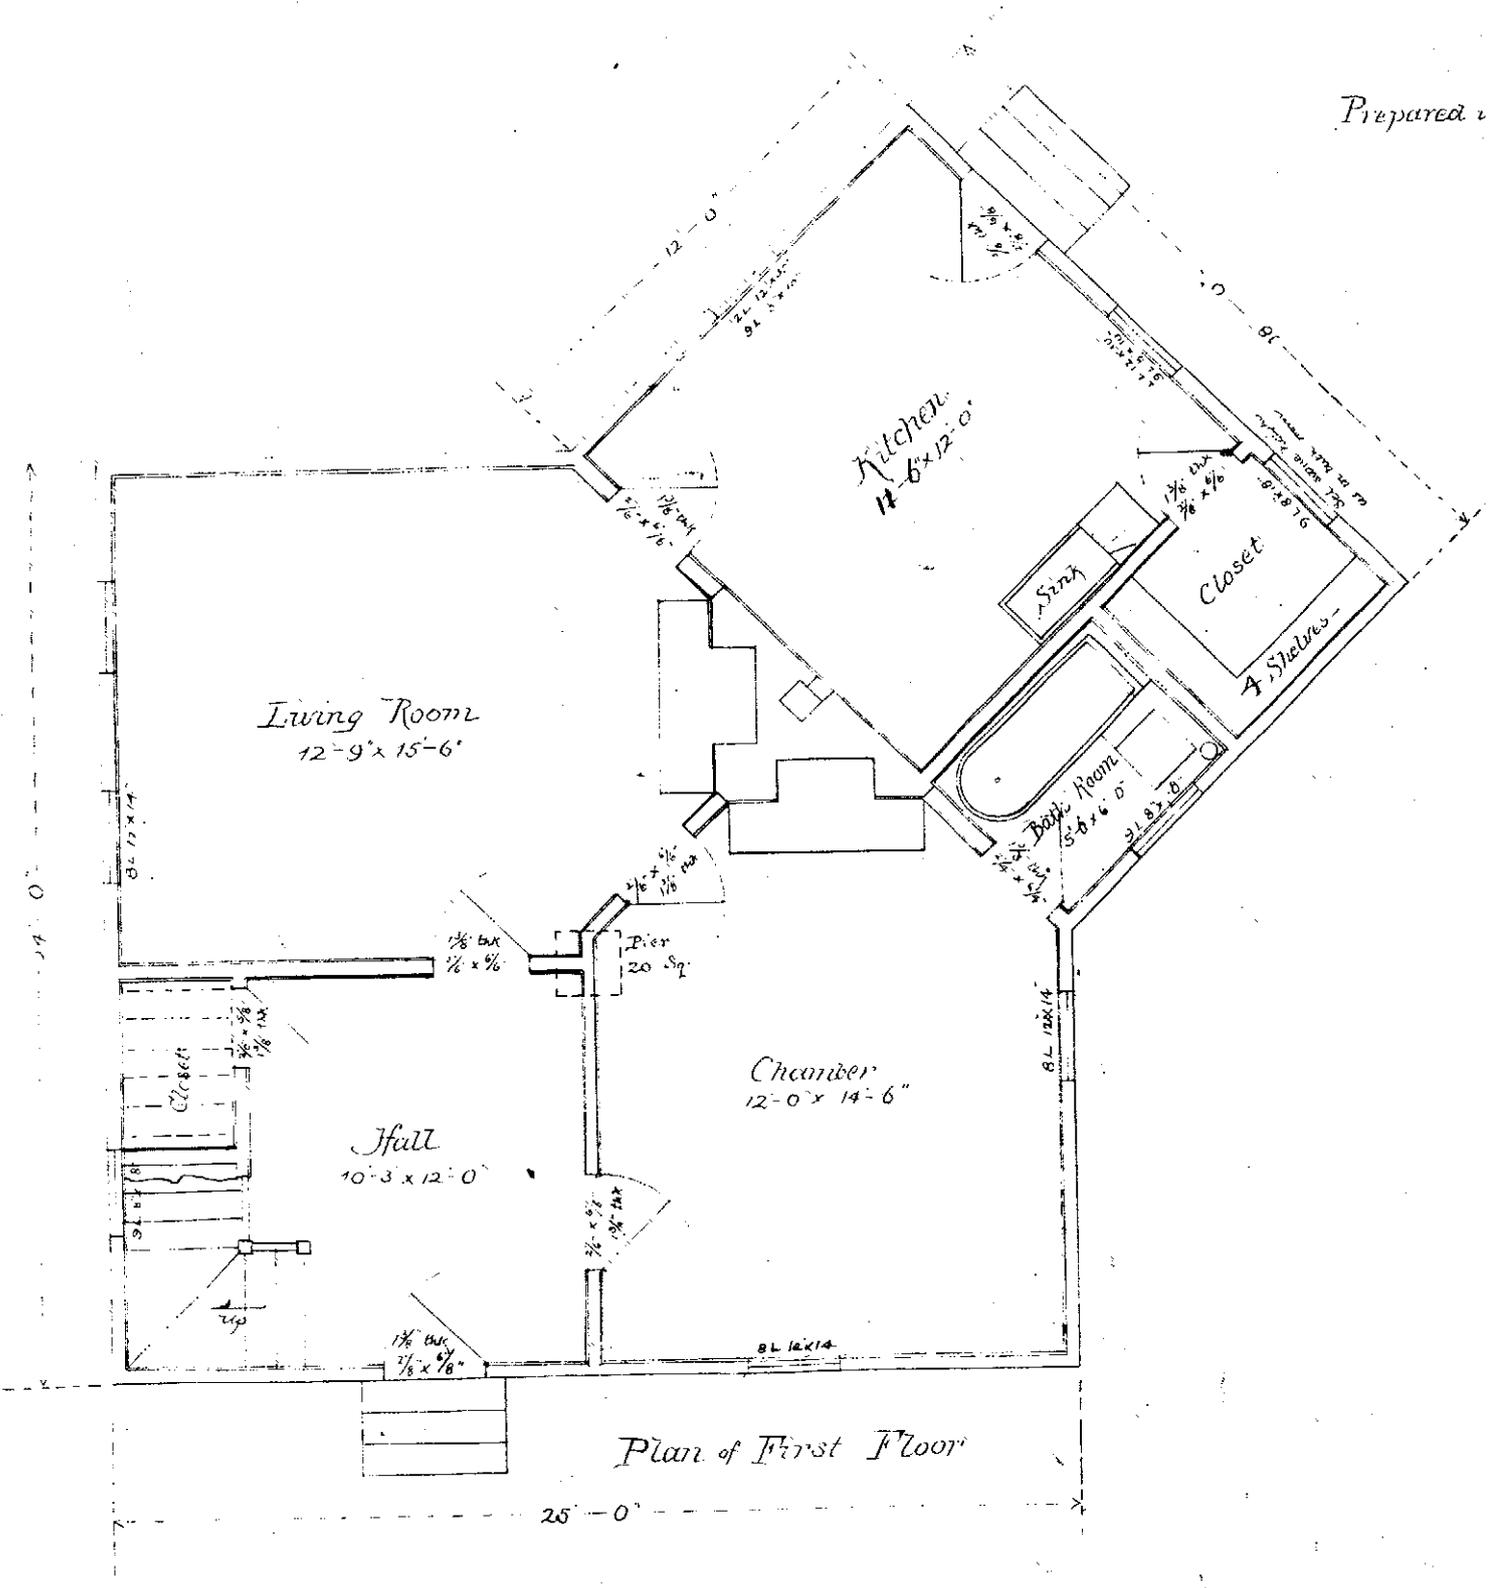
3. First Floor:

Plan of First Floor

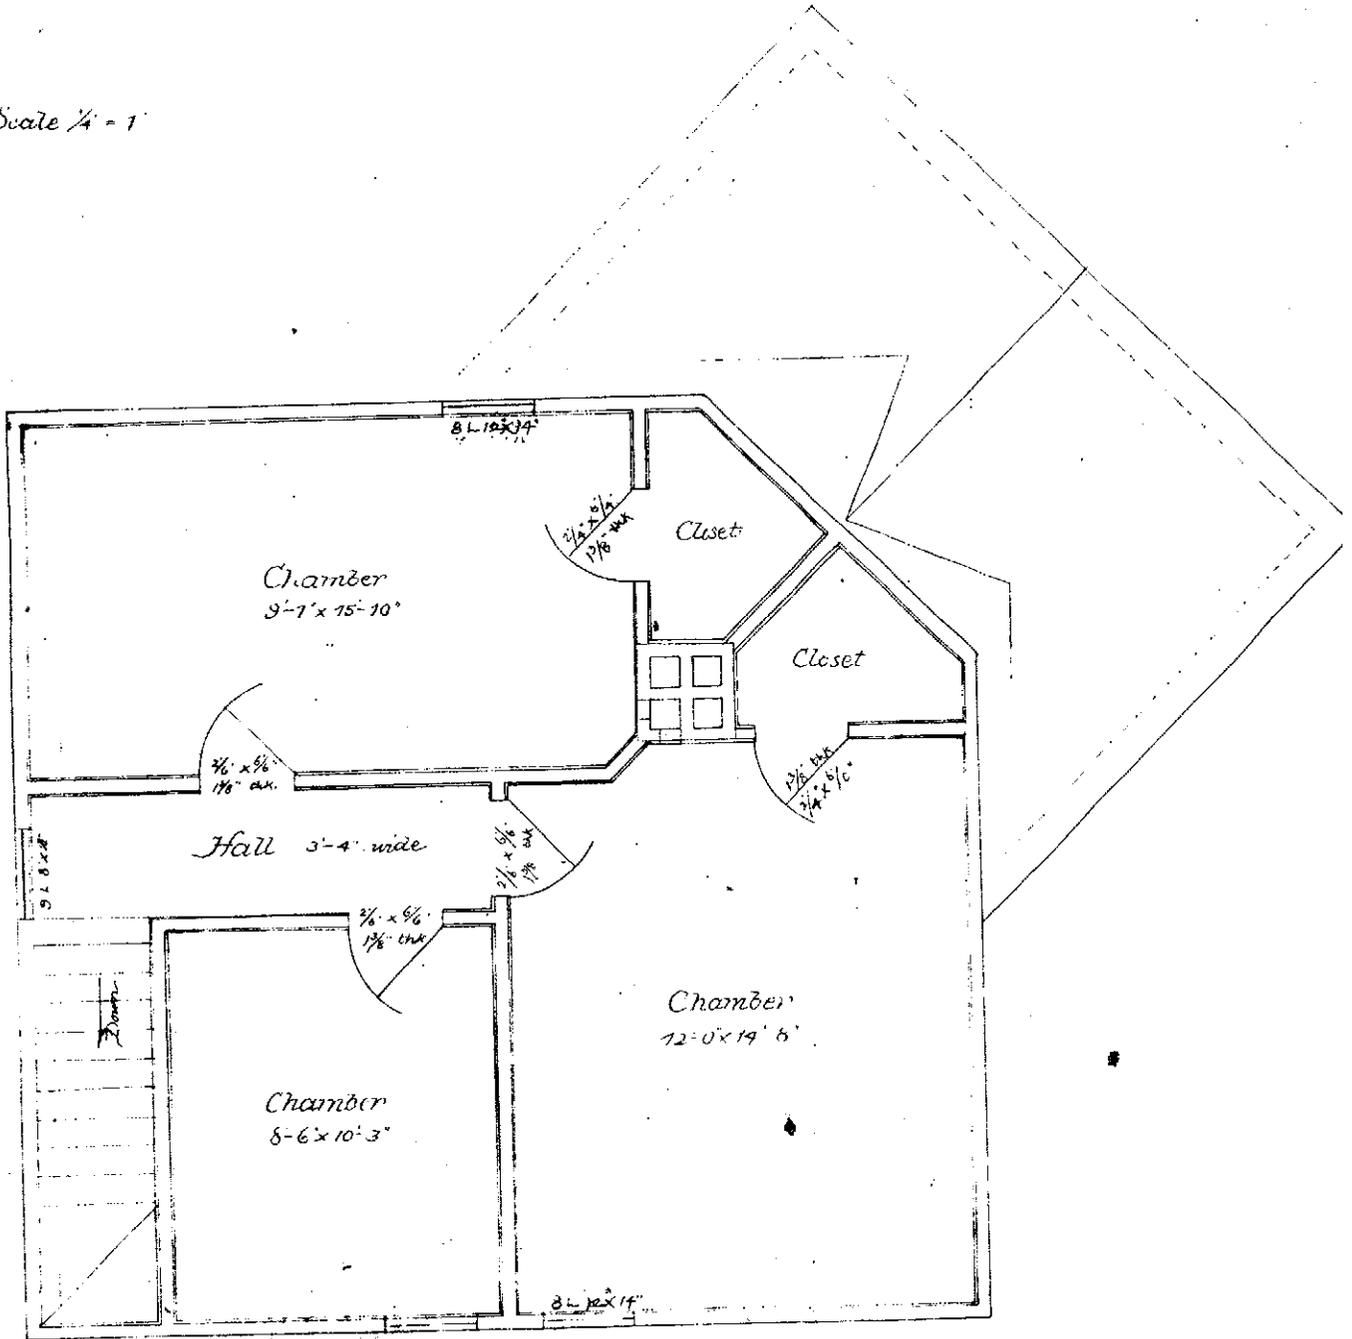
4. Second Floor

Scale 1/4" = 1'

Plan of Second Floor.

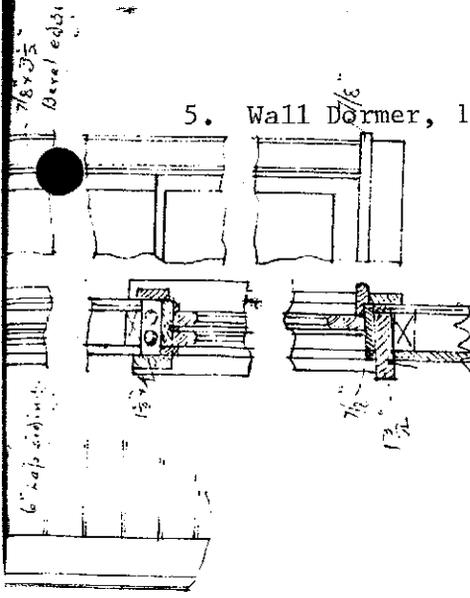
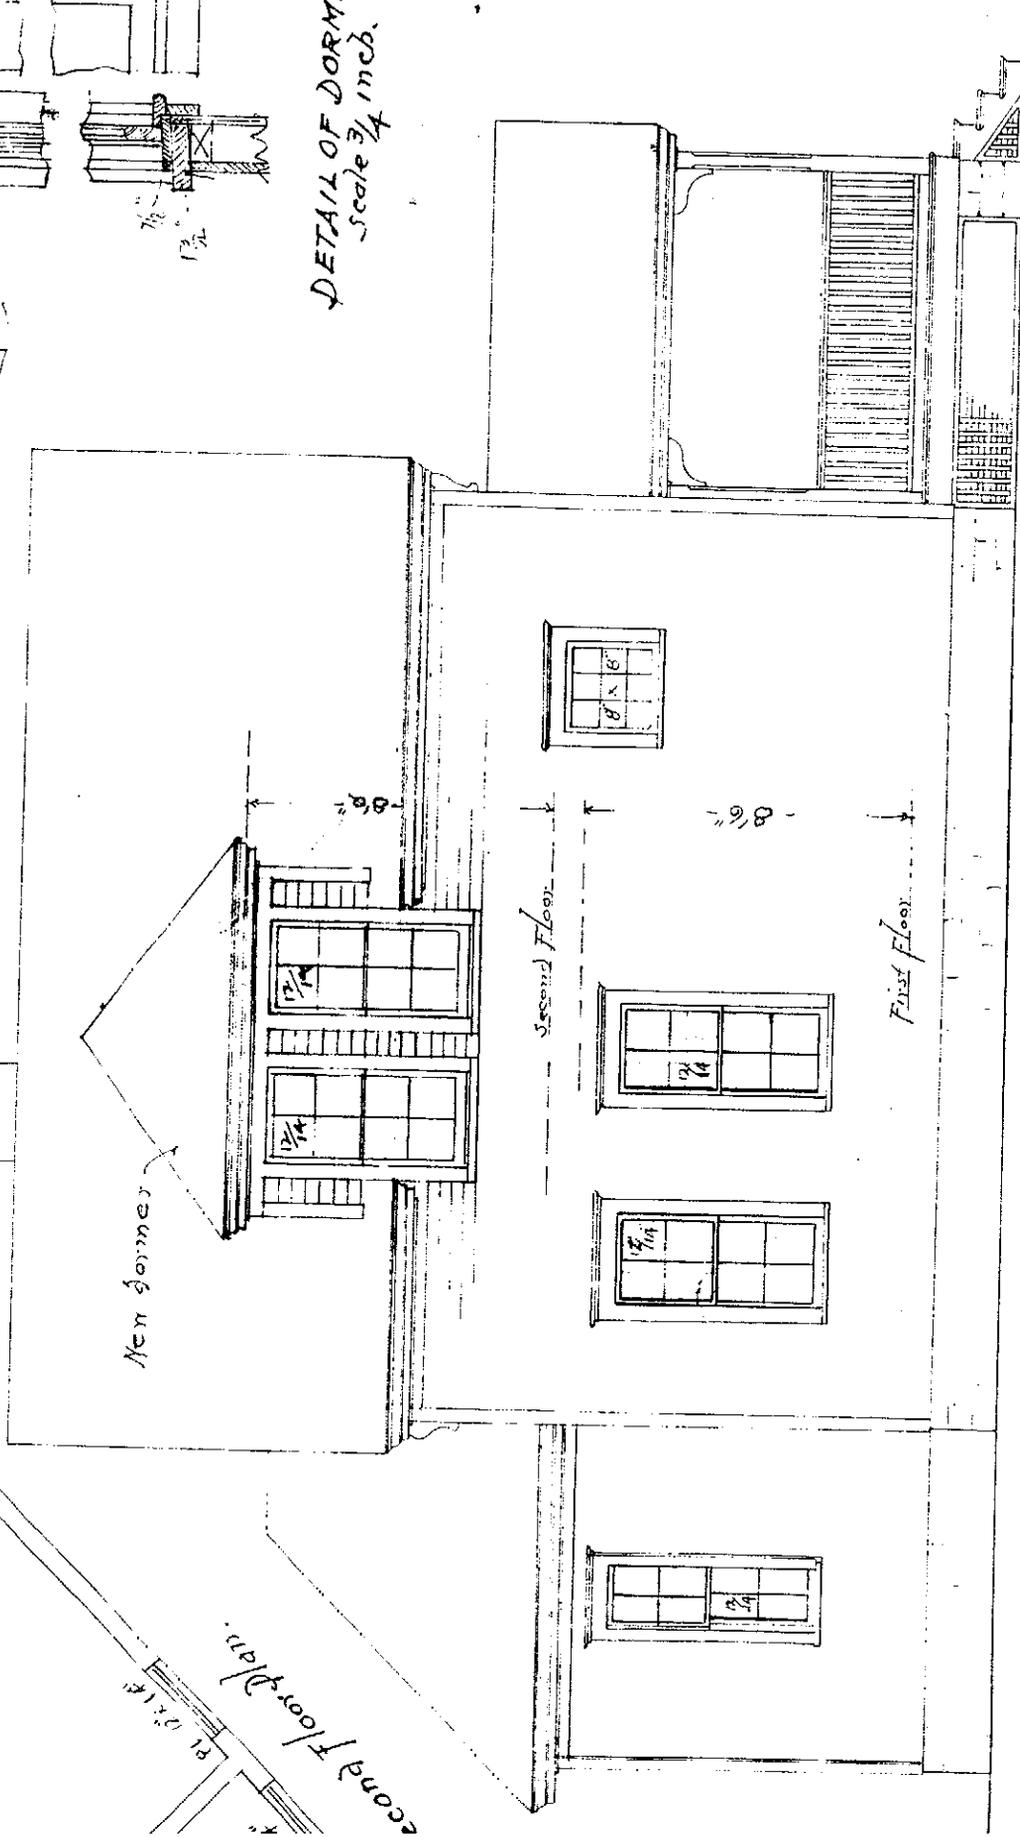
5. Wall Dormer, 1928 addition

DETAIL OF DORMERS
Scale $\frac{3}{4}$ inch.

Assigned Officers Bldg. "107."

elevations which replaced a small gable end with a single window (See HABS photos # KS-54-L-4 & 5 and Supplemental Materials # 5). Also, sometime between 1891 and 1928 a front gable entry porch was added. The porch is not present on original plans but appears in the 1928 plans. Also, at some point the entrance from the living room to the bathroom was covered up along with all the downstairs fireplaces. The downstairs full bath was converted to a half bath. Upstairs a full bath was added to the north, right of the west bedroom. To make room, builders shortened the north bedroom. They also added closets to all of the second floor bedrooms, and a hall linen closet east of the south bedroom door. The dates of these changes are unknown. The original central chimney has been removed as well as all fireplaces. An exterior chimney, though not original, still exists in the rear wing.

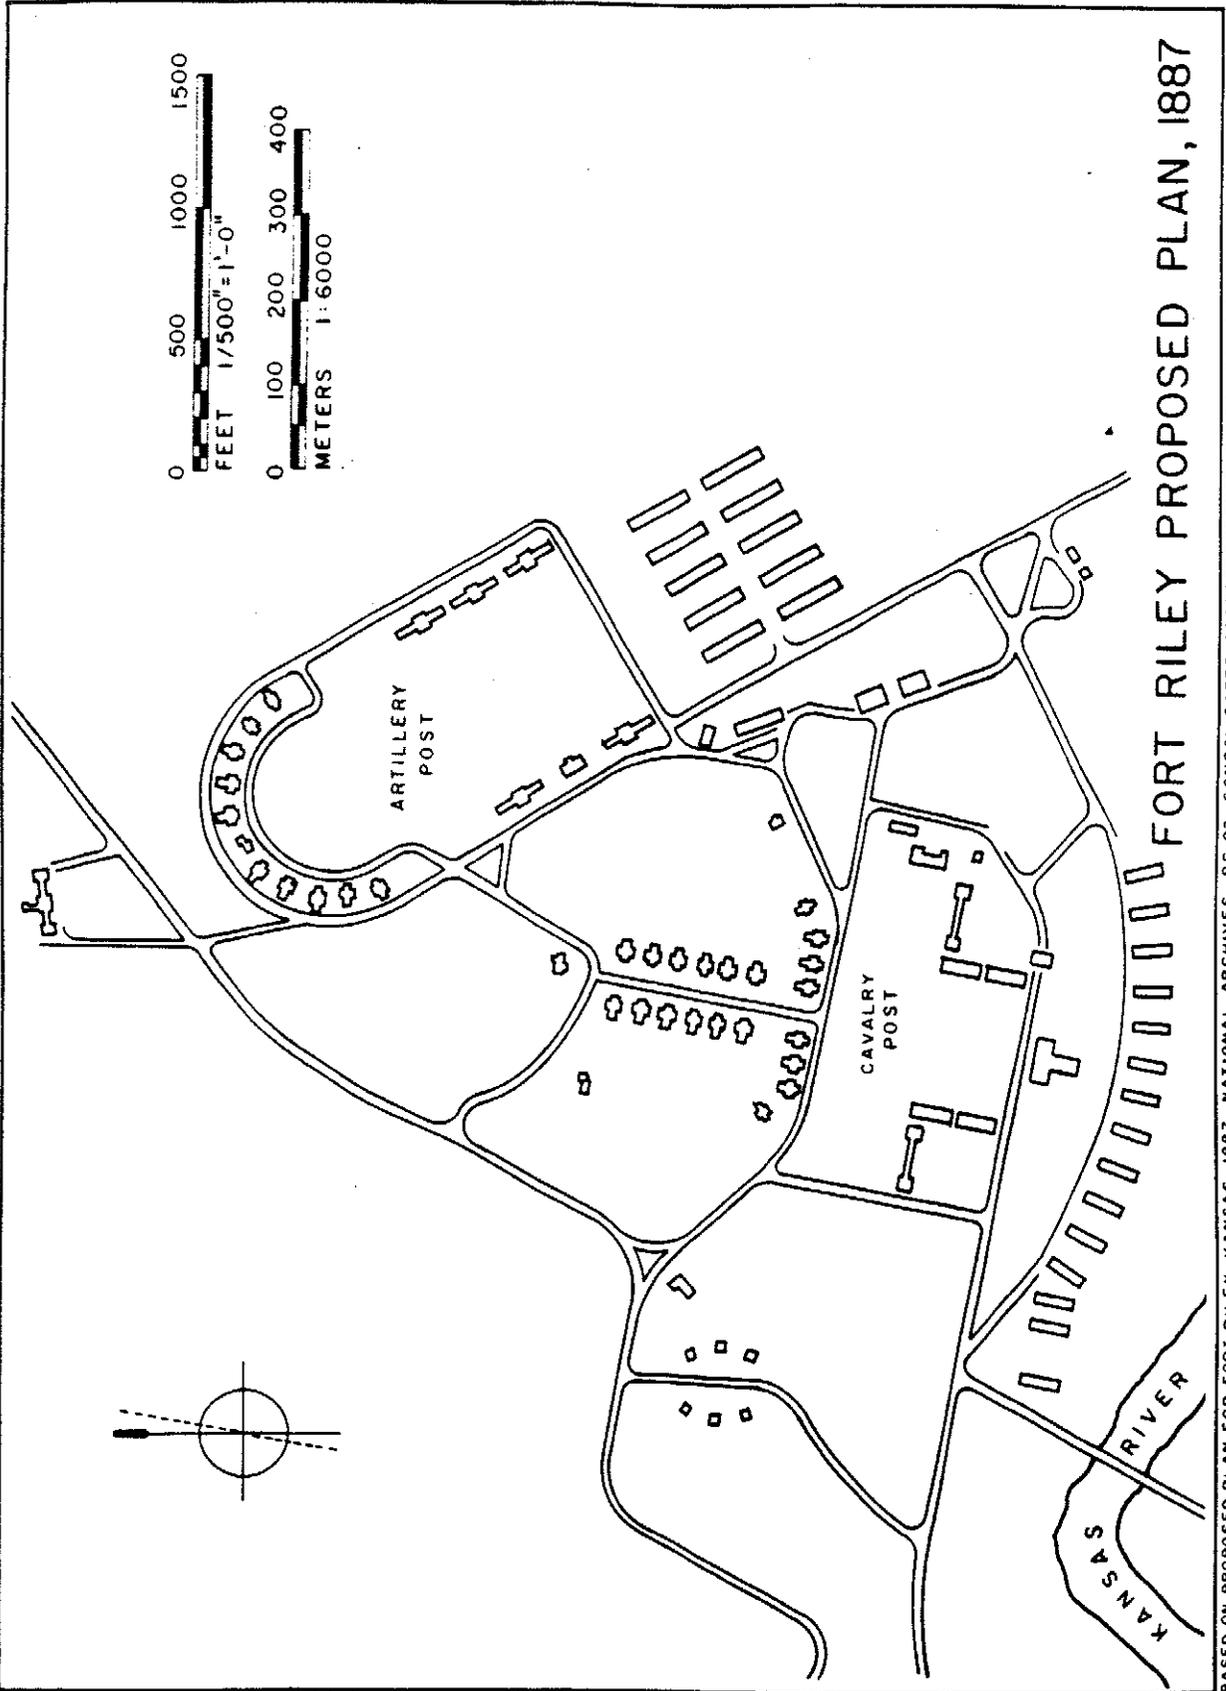
6. Fort Riley, Proposed Plan, 1887

PROPOSED PLAN, 1887 AND SITE PLAN, 1985

BASED ON PROPOSED PLAN FOR FORT RILEY, KANSAS, 1887. NATIONAL ARCHIVES, RG 92, CONSOLIDATED CORRESPONDENCE FILES, BOX 915
